Document D6-60083  
September 1967

**Some Characteristics of  
Aqueous Stress  
Corrosion in Titanium Alloys**

D.N. Fager and W.F. Spurr

The **BOEING** Company  
Commercial Airplane Division  
Renton, Washington

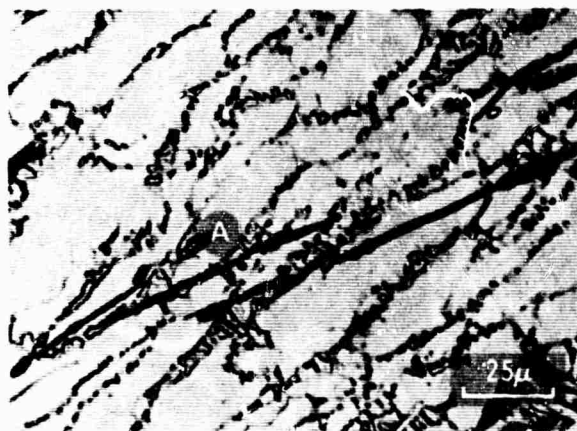
Fig. 1. Stress corrosion cracks in Ti-8Al-1Mo-1V 0.5-in. annealed plate, viewed normal to propagation direction (short transverse view). The  $\beta$ -phase particle at A behaves in a ductile manner.

Figures 1 and 2 show the transgranular fracture paths typical of aqueous stress corrosion in high- $\alpha$  alloys. The brittle fracture mode (cleavage) is shown at A in Fig. 3, along with ductile failure (B) due to unfavorable grain

orientation. Since cracks do not generally occur in the  $\beta$  phase of these high- $\alpha$  alloys, this phase appears to be immune to stress corrosion. Figure 1 illustrates this phenomenon in Ti-8Al-1Mo-1V, where the  $\beta$ -phase particle in the fracture path at A extends in a ductile manner instead of cracking. Other cracks in Ti-8Al-1Mo-1V (Fig. 2a), Ti-6Al-4V (Fig. 2b), and Ti-4Al-3Mo-1V (Fig. 2c) show a tendency to be either arrested or diverted by the  $\beta$  phase.

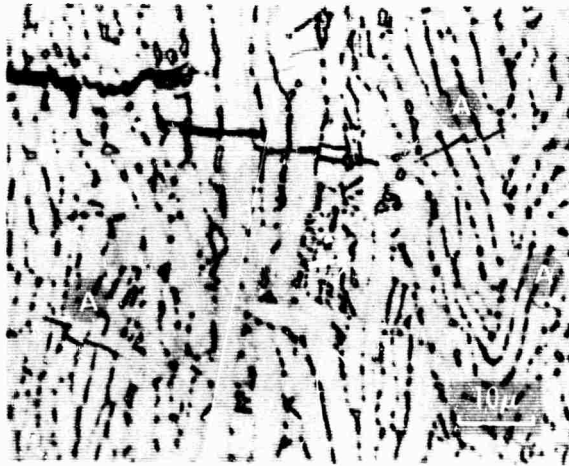
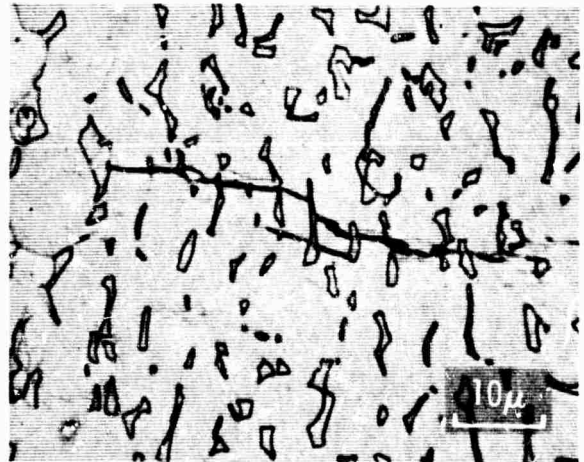
a. Ti-8Al-1Mo-1V (cracks at A remain normal to length of stringers).

b. Ti-6Al-4V.

Fig. 2. Stress corrosion cracks in high- $\alpha$  alloys (0.5-in. annealed plate), viewed parallel to propagation direction (longitudinal views).

c. Ti-4Al-3Mo-1V.

Grain orientation is a microstructural feature that significantly influences the fracture path. In Fig. 2a, as the direction of  $\alpha$  grain elongation changes from one area to

another, the cracks at A remain normal to the length of the elongated grains (stringers). As shown in Fig. 11 (where view A, identical with Fig. 2a, is normal to view B), the cracks are approximately normal to the surface shown in Fig. 2a; this observation was made several times. By using transmission electron microscopy, the basal planes (0001) in 75% of the stringers examined were found to be oriented approximately normal to the length (as shown

A comparison of the microstructures of Ti-8Al-1Mo-1V plate (Fig. 2a) versus sheet material (Fig. 19) shows that stringers are typical of plate but are much less common in the thinner gages, where equiaxed grains predominate. As in the earlier comparison between the Ti-6Al-4V and Ti-8Al-1Mo-1V 0.5-in. plate, this indicates that the equiaxed grains tend to have their

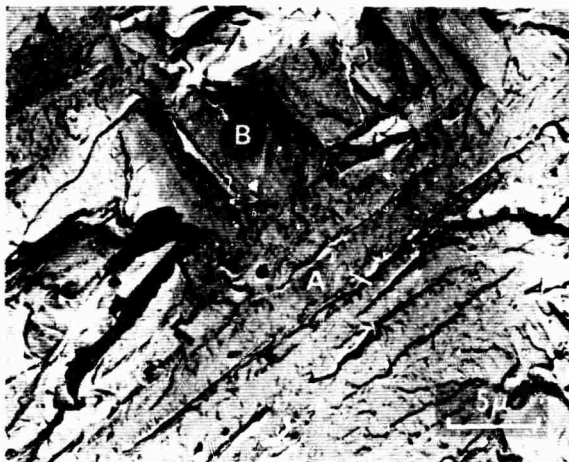
Fig. 3. Fractograph showing cleavage (A) in the single-phase hexagonal martensite of Ti-5Al-2.5Sn (2000 F/15 min/NQ). Ductile failure occurred at B.

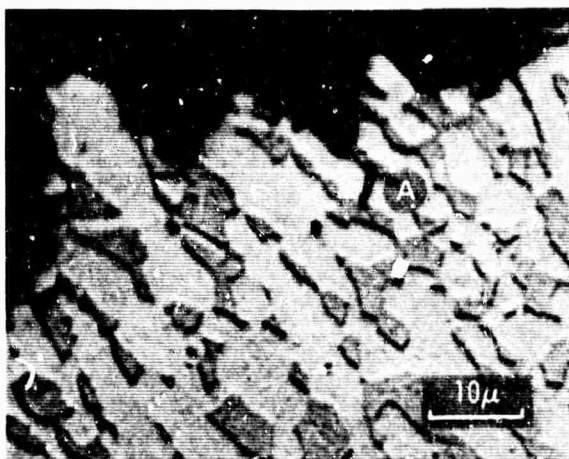
Fig. 4. Stress corrosion crack (A) in  $\alpha$  ending at  $\alpha'$  in Ti-8Al-1Mo-1V (1800 F/WQ).

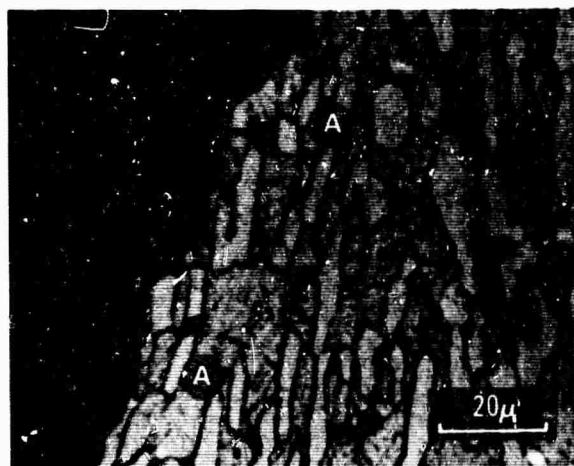
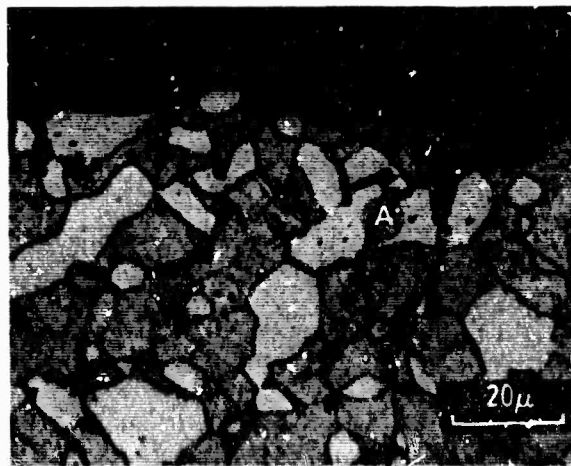
a. Viewed parallel to propagation direction.

b. Viewed normal to propagation direction.

Fig. 5. Stress corrosion cracks (A) in  $\alpha$  inhibited by  $\alpha''$  of Ti-8Al-1Mo-1V (1875 F/WQ).

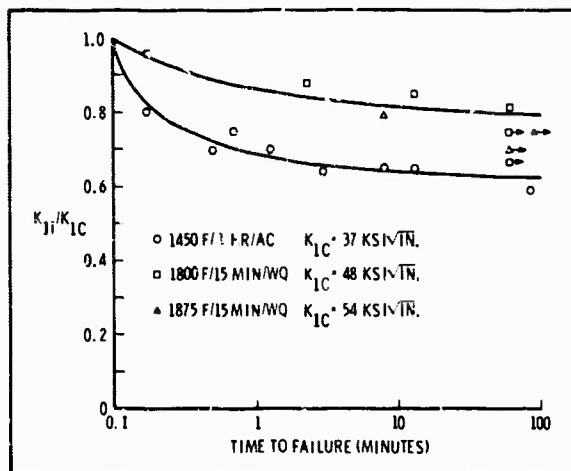
Fig. 6. Effect of high  $\alpha + \beta$  region treatments on Ti-8Al-1Mo-1V stress corrosion susceptibility (three-point-loaded notched bend specimens).

martensite that Blackburn (7) designates  $\alpha'$  and  $\alpha''$ . Figure 6 shows the increased stress corrosion resistance of the 1800°F and 1875°F solution-treatment conditions, compared with that of the annealed condition.

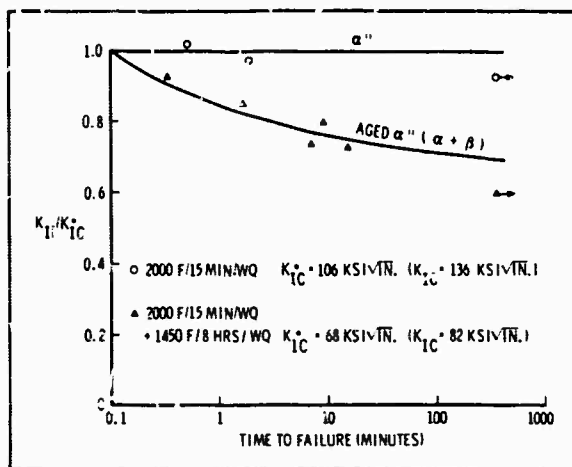
Fig. 7. Stress corrosion susceptibility of  $\alpha''$  and aged  $\alpha''$  ( $\alpha + \beta$ )—Ti-8Al-1Mo-1V (large four-point-loaded notched bend specimens).

[e.g. via Stroh's fracture mechanism (22)]. This does not appear reasonable, however, because when the immune  $\alpha''$  was aged, the structure became susceptible without any change in grain size (Fig. 7).

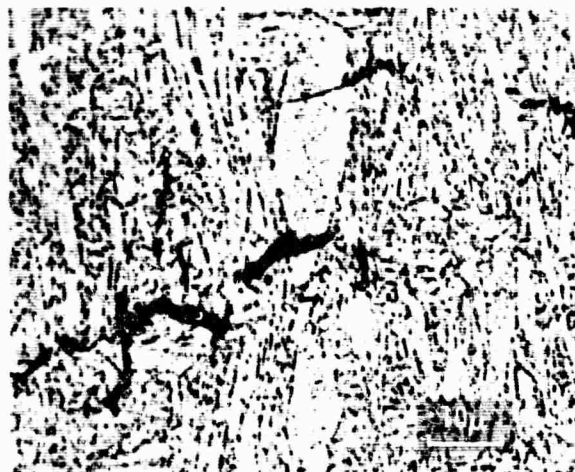
Fig. 8. Stress corrosion cracks in aged  $\alpha''$  ( $\alpha + \beta$ ) of Ti-8Al-1Mo-1V (2000 F/WQ + 1450 F/8 hr/WQ).

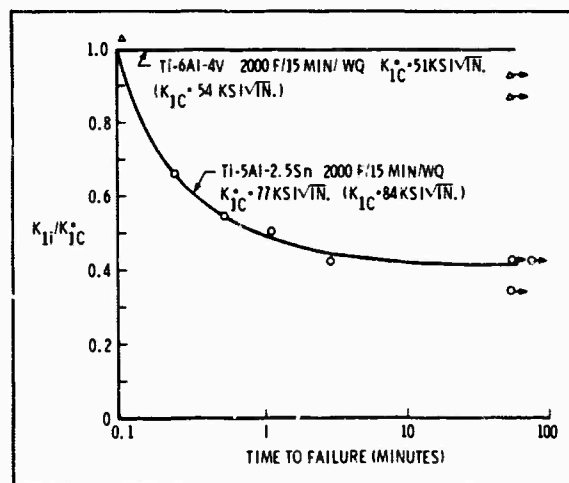
Fig. 9. Stress corrosion susceptibility of Ti-6Al-4V and Ti-5Al-2.5Sn martensites (three-point-loaded notched bend specimens).

was extremely susceptible (Fig. 9). Figure 10 shows a typical stress corrosion crack in the Ti-5Al-2.5Sn martensite. Cracks were frequently found to extend across many similarly oriented adjacent martensite plates. In areas where more variants of the martensitic transformation appeared, the crack path was less regular.

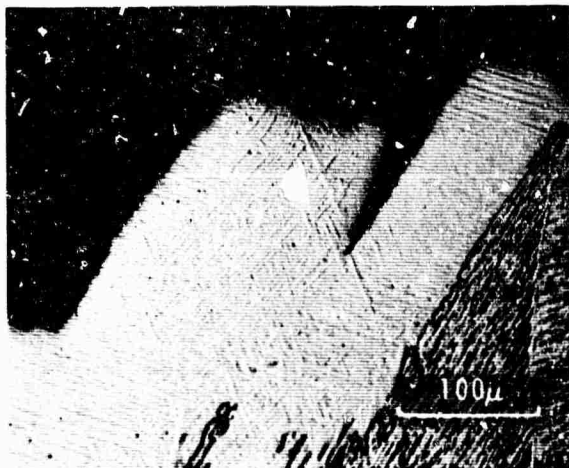
Fig. 10. Stress corrosion crack in Ti-5Al-2.5Sn martensite (2000 F/WQ).

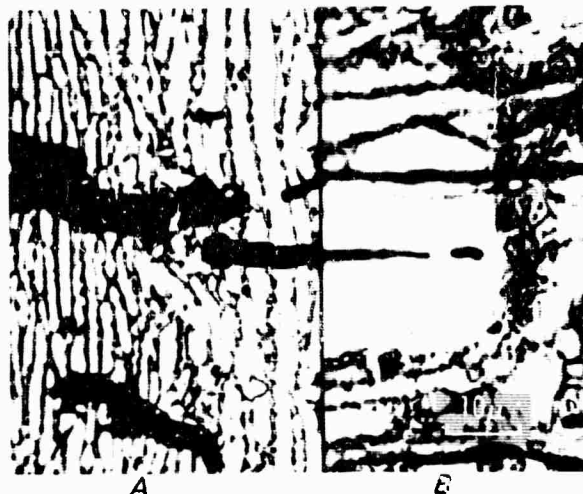
Fig. 11. Orientation of stress corrosion cracks in  $\alpha$  stringers of Ti-8Al-1Mo-1V. Two-surface metallography, A normal to b.

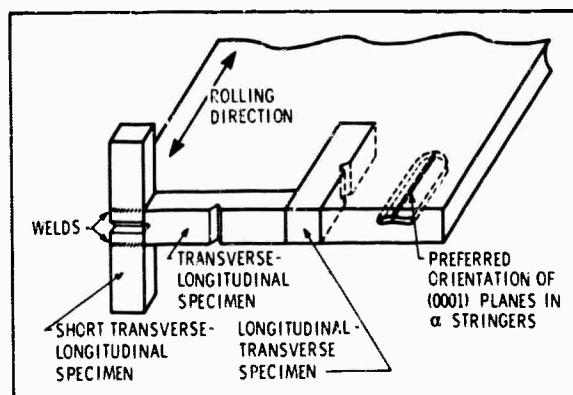
Fig. 12. Orientation of specimens in Ti-8Al-1Mo-1V 0.5-in. plate.

<sup>2</sup>The first direction is the grain direction from which the long dimension of the specimen was taken; the second, the direction of crack propagation. (See Fig. 12.)

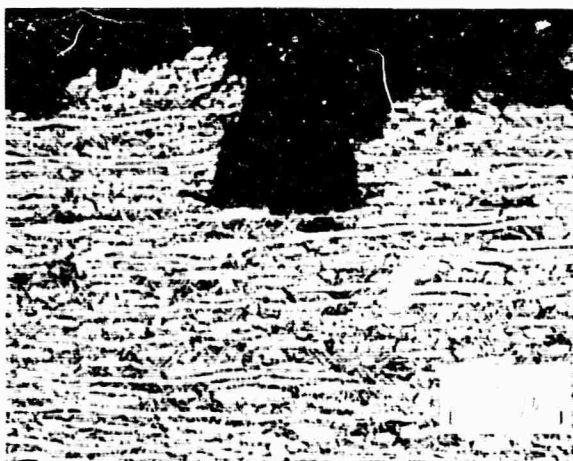
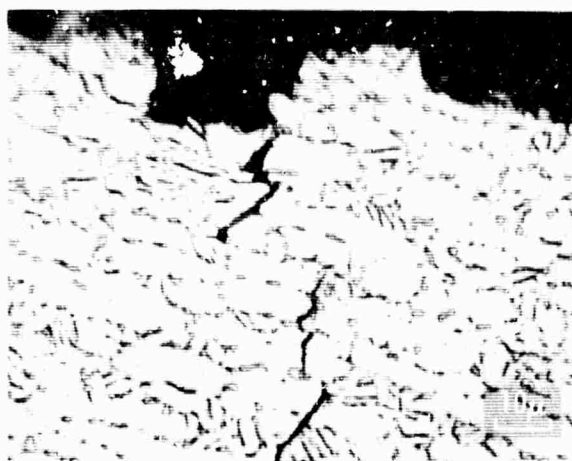
a. Fracture profile.

b. Secondary cracks.

Fig. 13. Cracking in short transverse specimens of Ti-8Al-1Mo-1V, viewed parallel to fracture face and to propagation direction.

Cracking in the short transverse-longitudinal specimens occurred on the same planes as in the transverse-longitudinal specimens, i.e. normal to the stringers, even though these planes were unfavorably oriented. This is shown in Fig. 13 where, to produce a continuous main crack, failure occurred in a ductile manner between the vertically cracked stringers. In the

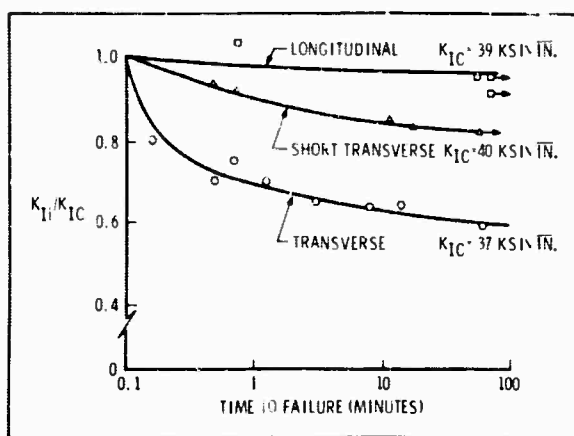
Fig. 14. Stress corrosion susceptibility as a function of specimen orientation in Ti-8Al-1Mo-1V 0.5-in. annealed plate (three-point-loaded notched bend specimens).

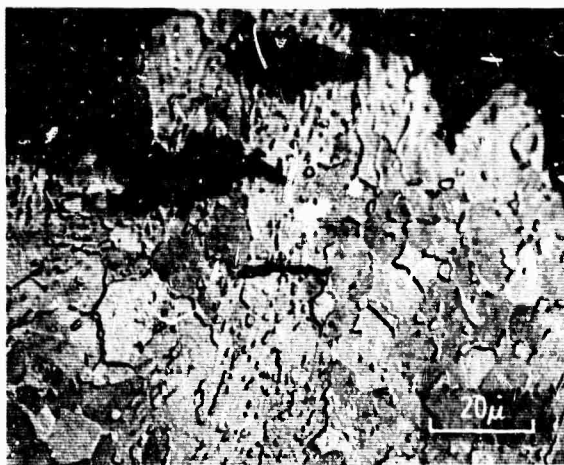
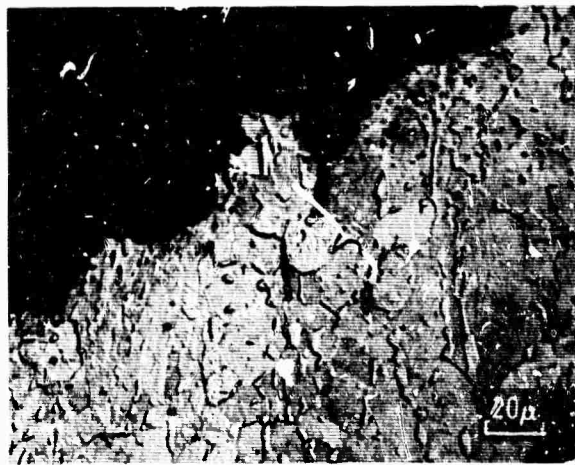
a. Cracks in  $\alpha$  stringer areas.

b. Cracks in equiaxed  $\alpha$  grains.

Fig. 15. Stress corrosion cracking in annealed Ti-6Al-4V 0.5-in. plate, viewed parallel to propagation direction.

The microstructure of the Ti-6Al-4V 0.5-in. material had areas with equiaxed  $\alpha$  grains which were not seen in the Ti-8Al-1Mo-1V, and had fewer stringer areas than the Ti-8Al-1Mo-1V. Cracking occurred normal to the stringers as in Ti-8Al-1Mo-1V (Fig. 15a) and was relatively continuous, inhibited only by the  $\beta$  phase. In contrast, cracking in the equiaxed  $\alpha$  grains was more nearly parallel to the plate surface (i.e. more normal to the fracture face; Fig. 15b) and was thus oriented less favorably for crack propagation. Cracking in these areas was not continuous. The cracks frequently changed direction at the grain boundaries.

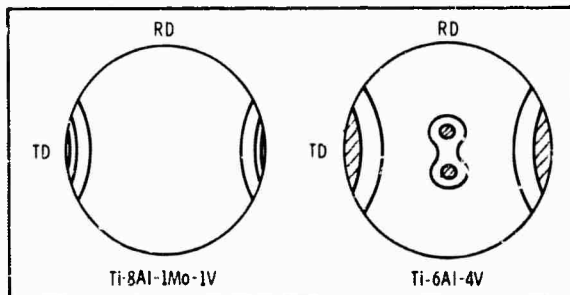
Fig. 16. Schematic (0001) pole figures of Ti-8Al-1Mo-1V and Ti-6Al-4V 0.5-in. annealed plate.

in Fig. 2a) of the stringers. This is consistent with a pole figure determination (see Fig. 16) in which the (0001) planes were preferentially oriented normal to the plate surface and parallel to the rolling direction. The (0001) planes thus correspond approximately to the observed fracture planes.

This difference in grain morphology and crack orientation is consistent with the difference between the pole figures for the Ti-6Al-4V and Ti-8Al-1Mo-1V 0.5-in. materials. A double texture was observed in the Ti-6Al-4V: the (0001) planes were preferentially oriented either within  $40^\circ$  or at  $90^\circ$  to the plate surface, compared with  $90^\circ$  for the Ti-8Al-1Mo-1V (Fig. 16). [The central Ti-6Al-4V texture was rotated  $90^\circ$  about its center in relation to the textures normally reported for sheet material (11).] The variation in microstructure and associated texture can account for the difference in stress corrosion susceptibility between the Ti-6Al-4V and Ti-8Al-1Mo-1V (Fig. 17). Examination of other sheets and heats of Ti-8Al-1Mo-1V and Ti-6Al-4V has shown a large variation in micro-

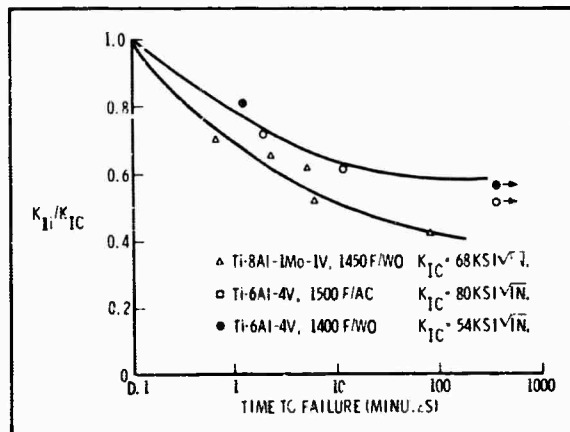
Fig. 17. Stress corrosion susceptibility of Ti-8Al-1Mo-1V and Ti-6Al-4V 0.5-in. annealed plate (large four-point-loaded notched bend specimens).

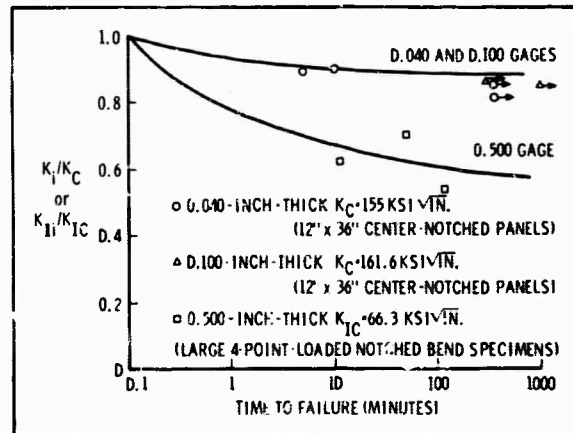
Fig. 18. Influence of thickness on stress corrosion susceptibility of annealed Ti-6Al-4V.

In addition to the stress state, preferred orientation apparently also contributes to the thickness effect. As shown in Fig. 18, relative immunity is obtained in Ti-6Al-4V at a gage thickness of 0.100 in. This is inconsistent with Wald's data (12), where 0.050 in. was the greatest thickness at which Ti-6Al-4V showed relative immunity. This can be explained by the change in preferred orientation with thickness observed in high- $\alpha$  alloys. Baggerly (Ref. 14 and private communication) has shown by X-ray diffraction in Ti-8Al-1Mo-1V and Ti-6Al-6V-2Sn that the (0001) planes in the 0.5-in.-thick material are oriented preferentially normal to the plate surface and parallel to the rolling direction. Examining thinner-gage material, he found that the texture changes to that usually reported (11) for titanium alloys; i.e. the (0001) planes are tilted 20° to 30° from the plane of the sheet surface. The (0001) planes are thus less favorably oriented for cracking in processed sheet gage than in plate material thinned to sheet dimensions (transverse specimens).

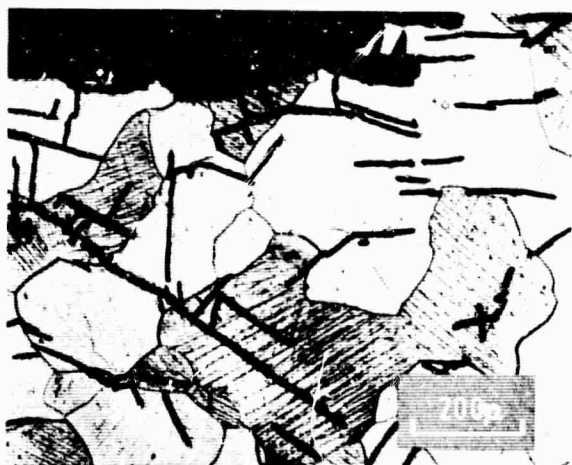
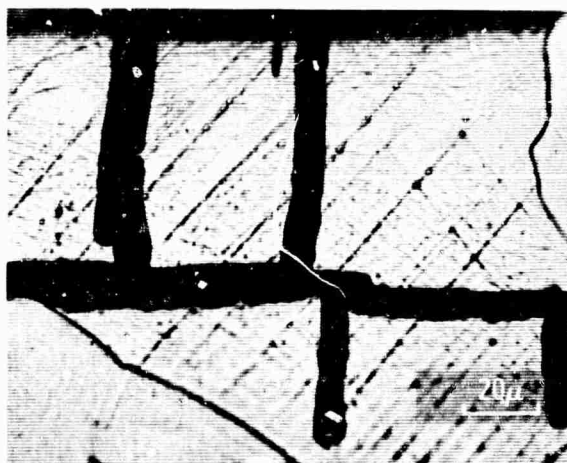
a.  $\times 75$ .

b.  $\times 400$ .

Fig. 20. Stress corrosion cracking in the  $\beta$  phase of solution-treated Ti-13V-11Cr-3Al (1575 F/WQ).

Stress corrosion cracks in the  $\beta$  phase of Ti-13V-11Cr-3Al are crystallographic (Fig. 20). Cracks commonly occur on two or sometimes three different crystallographic planes in a single grain. This is in contrast to the single-plane cracking normally observed in the  $\alpha$  phase of the high- $\alpha$  alloys. Figure 21 demonstrates the brittle fracture mode in the  $\beta$  phase; note the grain boundary extending through A and B and

A lactic-acid etch was used to reveal the slip lines in the deformed grains of this alloy (Fig. 20). Many of the lines were composed of individual dislocation etch pits. An analysis of the relation between the cracks and slip lines in one surface showed that in about 60% of the cases where two or more different slip systems were observed in a single grain, the cracks roughly bisected them. This, together with the assumption that slip occurs mainly on the  $\{110\}$  planes, indicates that cracking occurs on the  $\{100\}$  planes. Crack branching in single grains was extensive, yet no more than three fracture-plane orientations were observed by use of one-surface and two-surface metallography. This tends to eliminate all planes except the  $\{100\}$  and (possibly) the  $\{111\}$ .

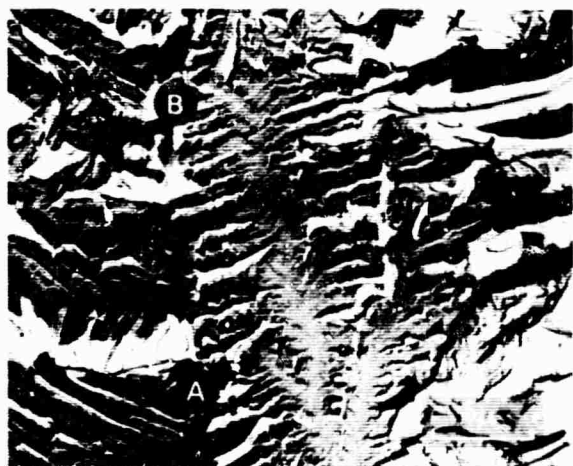
Fig. 21. Fractograph of the  $\beta$  phase of solution-treated Ti-13V-11Cr-3Al (1575 F/WQ). Grain boundary extends through A and B.

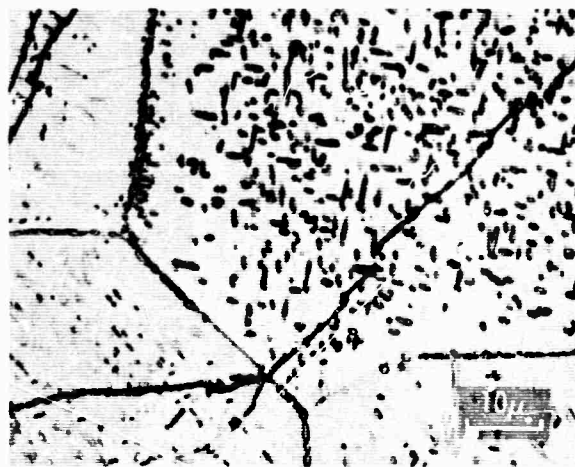
Fig. 22. Effect of  $\alpha$  precipitate on crack propagation of solution-treated-plus-aged Ti-13V-11Cr-3Al (1725 F/WQ + 1200 F/WQ).

Cracking in the  $\beta$  phase of this alloy is inhibited to some extent when the  $\alpha$  phase is present as the result of an aging treatment (Fig. 22). As shown, the cracks take irregular paths through the  $\beta$  grains. (Note in Fig. 22 that slip lines are no longer observed after etching.) The crack inhibition by the  $\alpha$  does not necessarily mean that this phase is immune in this alloy. Assuming that cracks occur on the {100} planes in the  $\beta$  and on the (0001) in the  $\alpha$ , crack inhibition would be expected from the Burgers relationship  $\{110\}_{\beta} \parallel (0001)_{\alpha}$ . A fractographic analysis to determine whether the  $\alpha$  precipitate failed by stress corrosion was inconclusive.

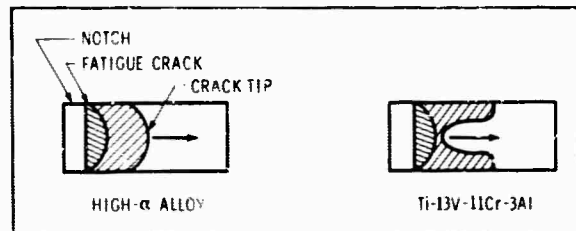
**Fig. 23. Stress corrosion crack-tip shapes for Ti-13V-11Cr-3Al and typical high- $\alpha$  alloy.**

showed that cracks had initiated on the surfaces in the plastic yield zones, independent of the main crack. This effect produced the unusual crack tip shape shown schematically in Fig. 23.

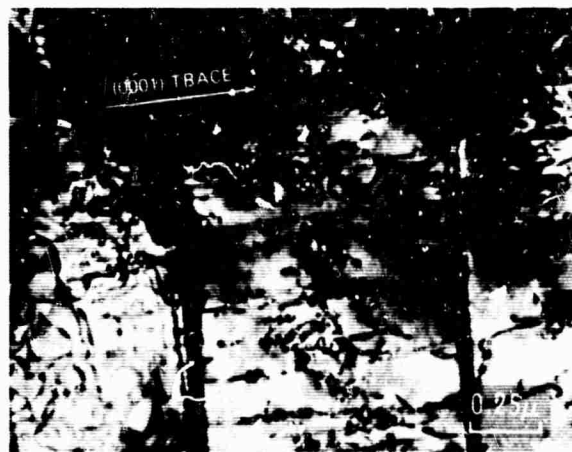
Fig. 24. Transmission electron micrograph of Ti-5Al-2.5Sn martensite (2000 F/WQ).

The hexagonal martensite of Ti-5Al-2.5Sn has a typical acicular structure with internal stacking faults (Fig. 24). Coplanar dislocations are found in some grains upon deformation at room temperature, indicating a tendency toward coplanar arrays rather than tangles if the orientation is suitable. This phase has the low ductility (about 8% elongation) typical of the titanium martensites. Many areas of its structure show only one variant of the martensitic transformation (see Fig. 10), compared with a minimum of three always observed in Ti-8Al-1Mo-1V. This is evidently a function of the cooling rate: in thinner material quenched from 2000°F, these areas are much reduced. Otherwise, the structure and deformation characteristics of this phase are similar to those of  $\alpha''$  in Ti-8Al-1Mo-1V.

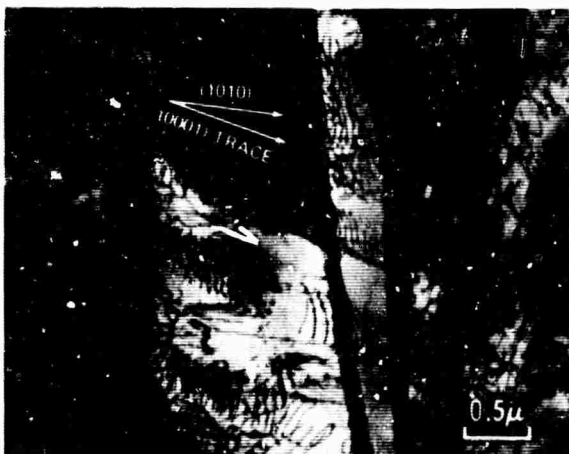
Fig. 25. Transmission electron micrograph of dislocation structure after ~2% plastic strain in the  $\alpha''$  phase of Ti-8Al-1Mo-1V.
